# FACE FACTS

Fatality Assessment & Control Evaluation

## EMPLOYEE DIES AFTER BEING CRUSHED IN A BALER

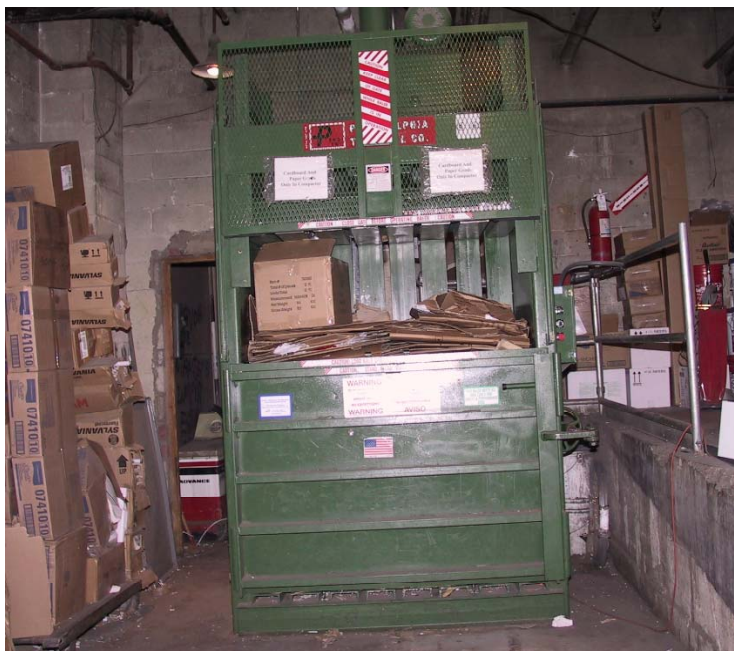
A department store processing manager died after he was crushed in a cardboard baling machine. The safety gate was not closed prior to his pushing the “down” button to begin baling. In addition, for an unknown reason, the employee climbed into the baling chamber where he was crushed by the baler’s hydraulic ram. A post-incident baler examination found that the electrical wiring had been altered to bypass the “On or Off” switch, and the gate safety switch had been short-circuited by a piece of two-inch wire. By doing so, power was always supplied to the machine and the baling machine could operate with the safety gate up. (Case Report: 04NY013)

- ▶ Inspect all baling machines periodically to ensure safety features are working properly.
- ▶ Develop, implement, and enforce a baling machine safety program.
- ▶ Provide training and ensure management and other employees know and understand the importance of baler safety features, such as the safety gate and lockout/tagout program, and how they work.
- ▶ Ensure authorized baler operators follow standard safe operating procedures.
- ▶ Follow the manufacturer’s recommended schedule for baling machine maintenance.
